PHOTOGRAPHIC DOCUMENTATION

Investigation Date: 11/20/2015

Facility Name: Lane Plating

EPA ID No: TXD007336571; SWR No: 31215

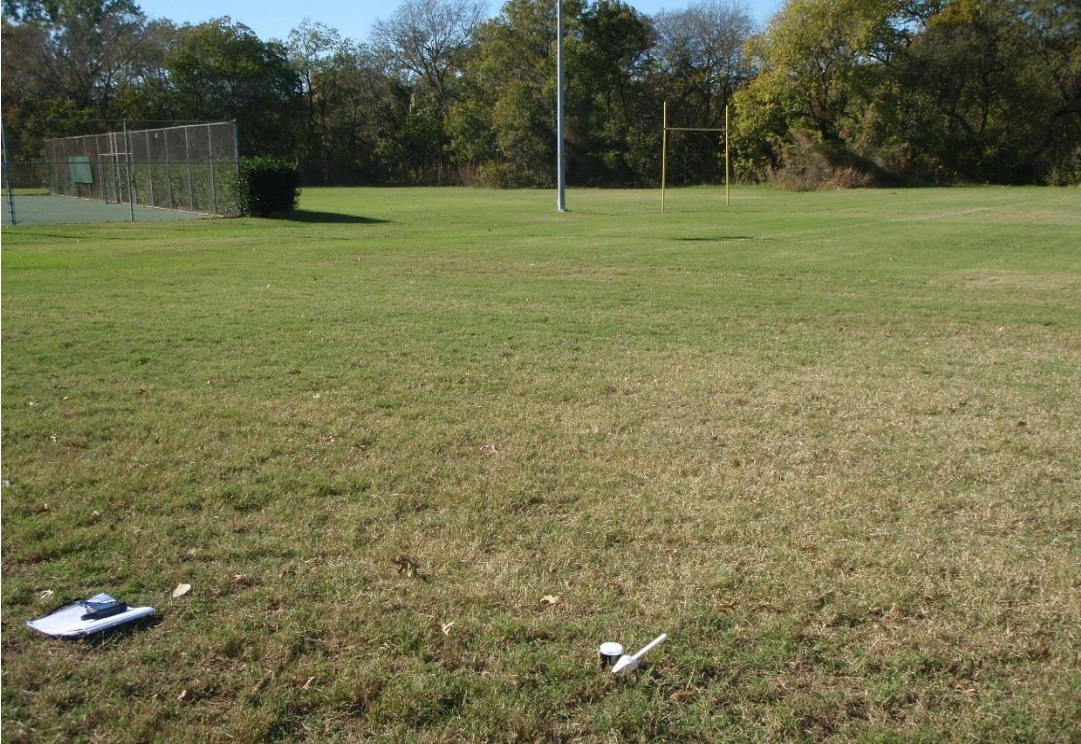
Photograph #1

Comments: Background sample collected from College Park located approximately half a mile southeast of the facility.

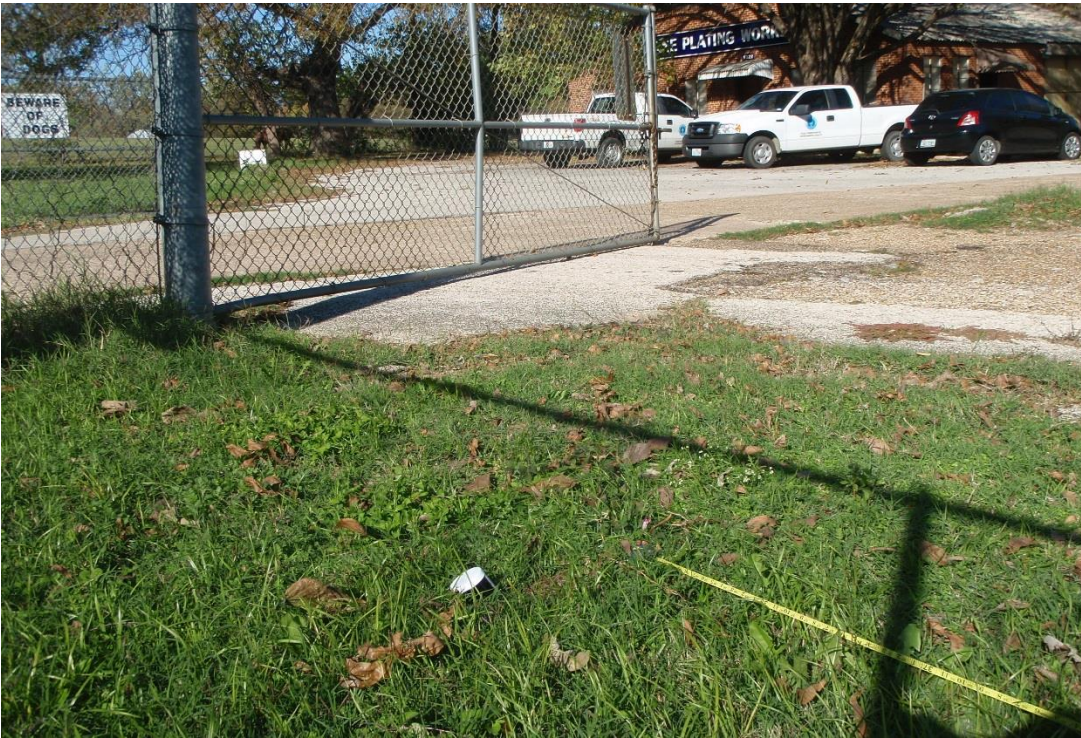
Photograph #2

Comments: Soil Sample

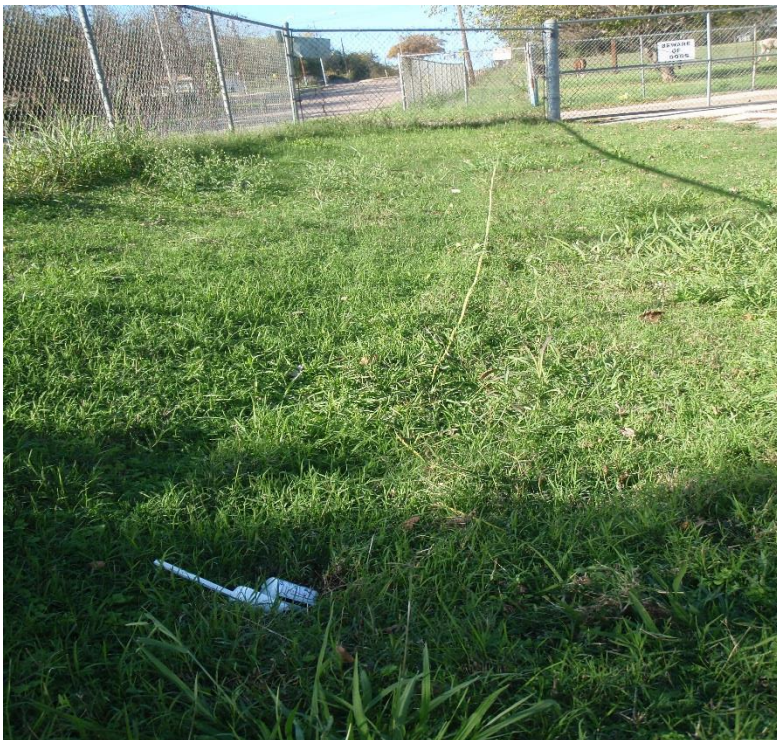
Photograph #3

Comments: Soil Sample

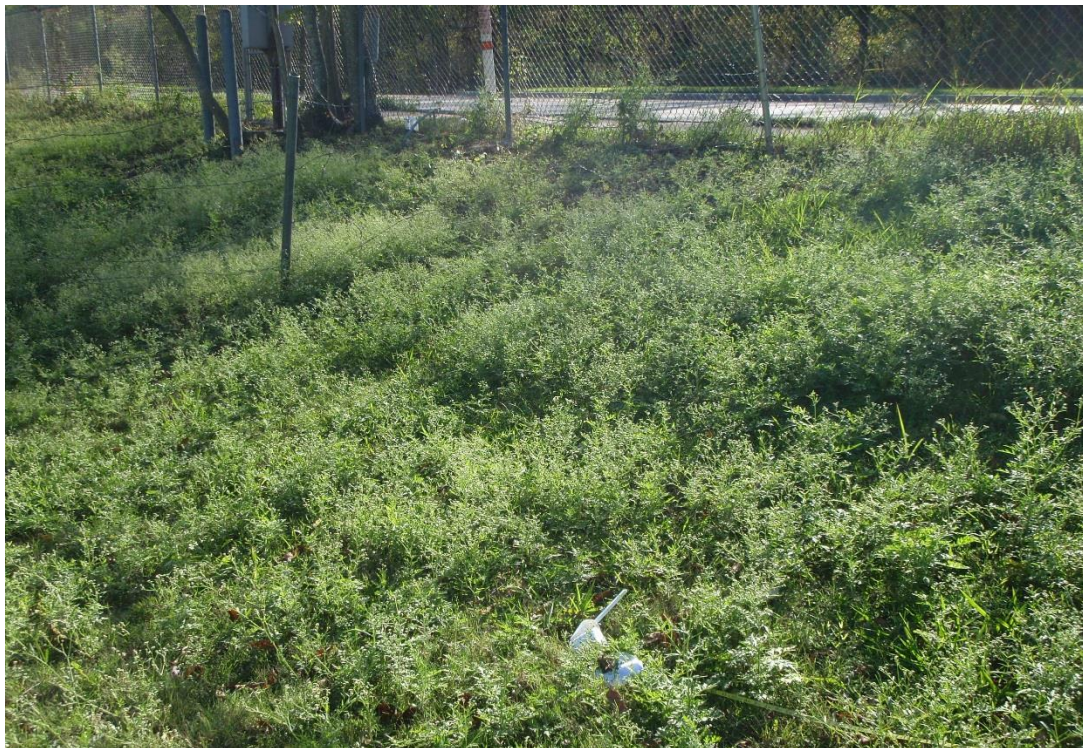
Photograph #4

Comments: Soil Sample

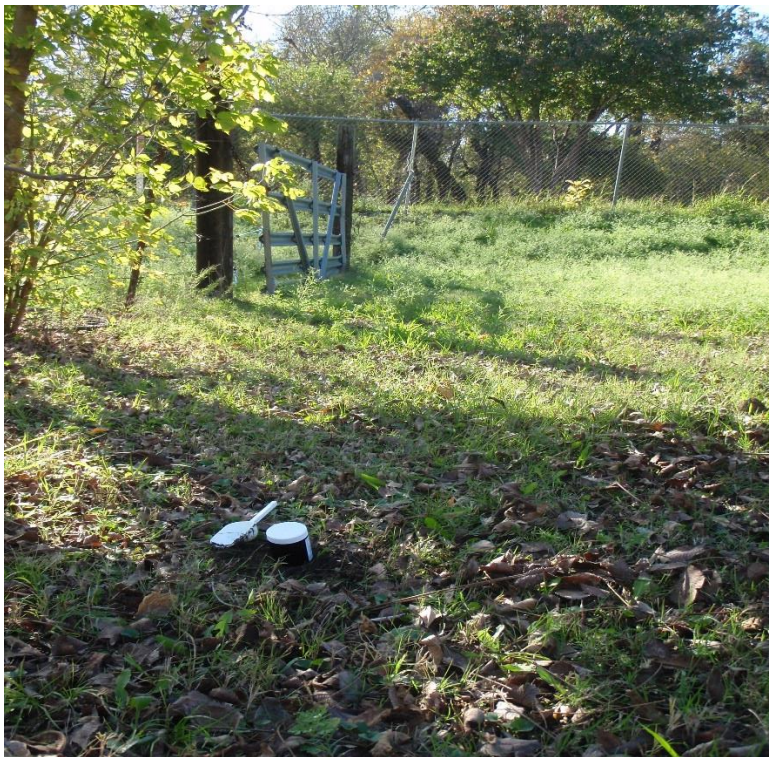
Photograph #5

Comments: Soil Sample

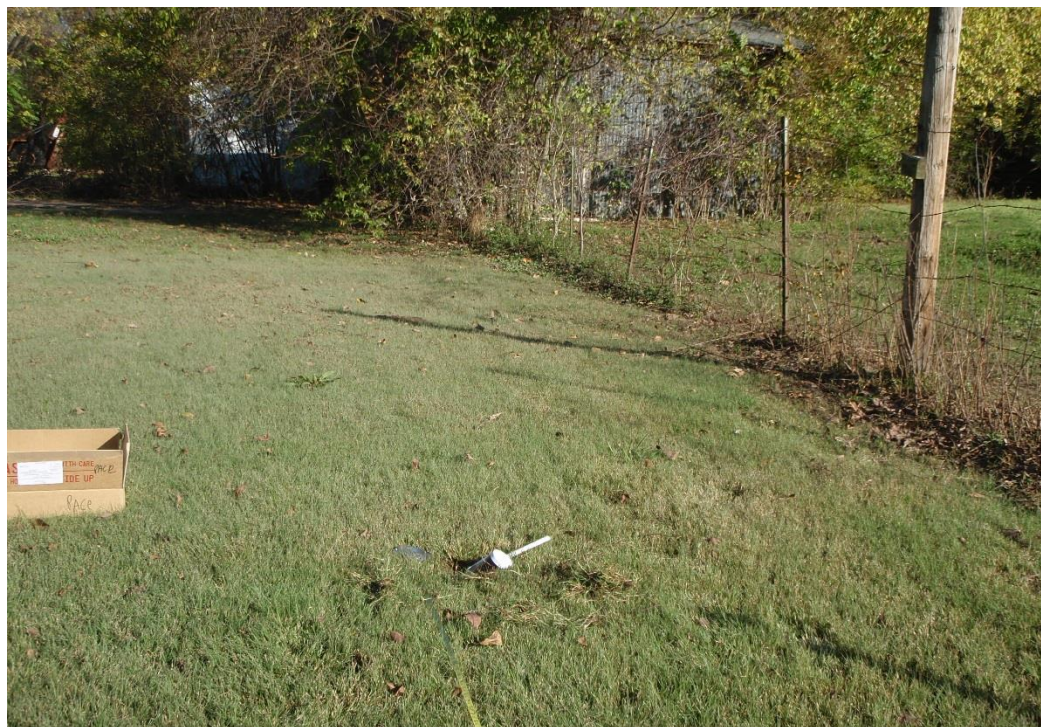
Photograph #6

Comments: Soil Sample

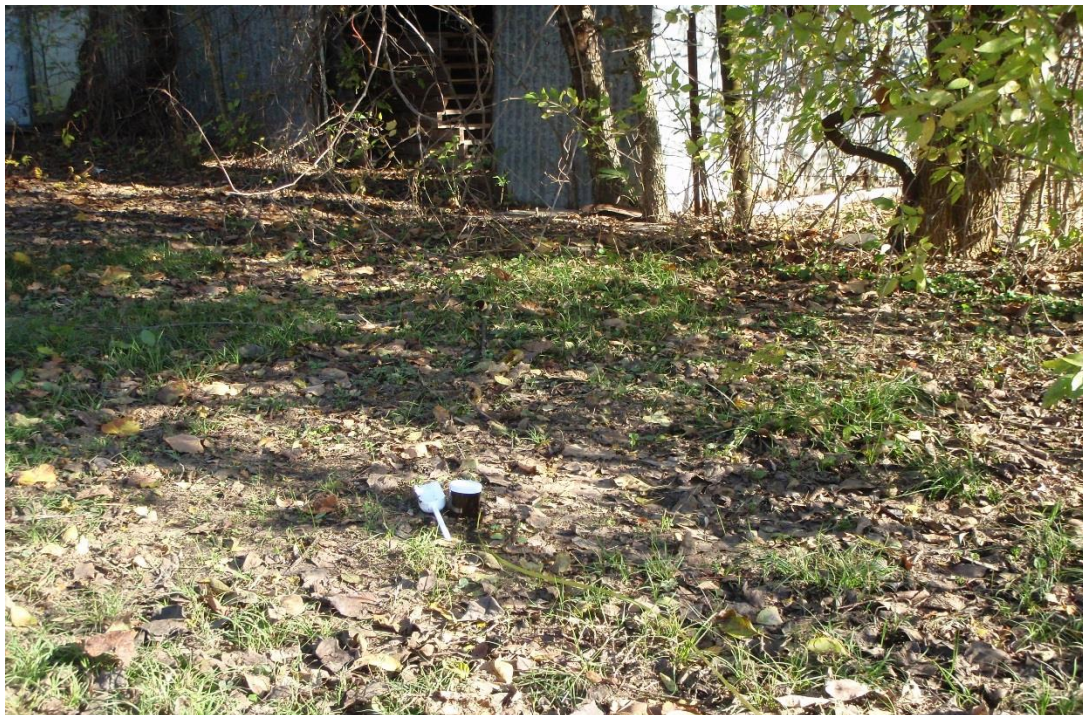
Photograph #7

Comments: Soil Sample

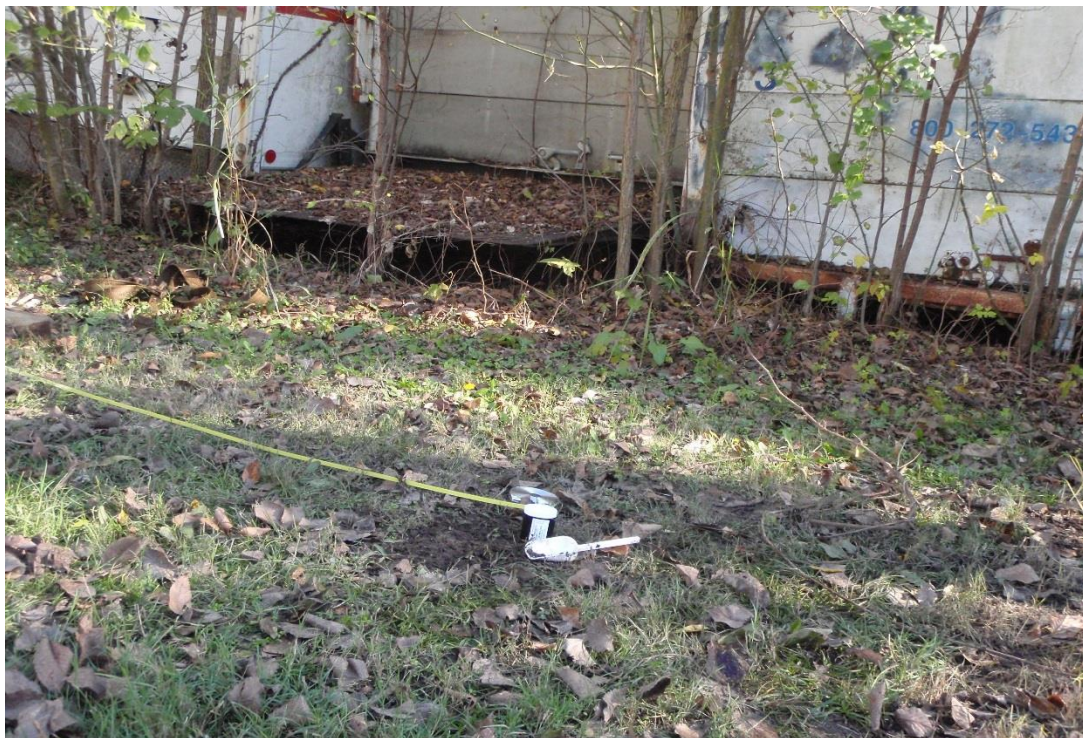
Photograph #8

Comments: Soil Sample

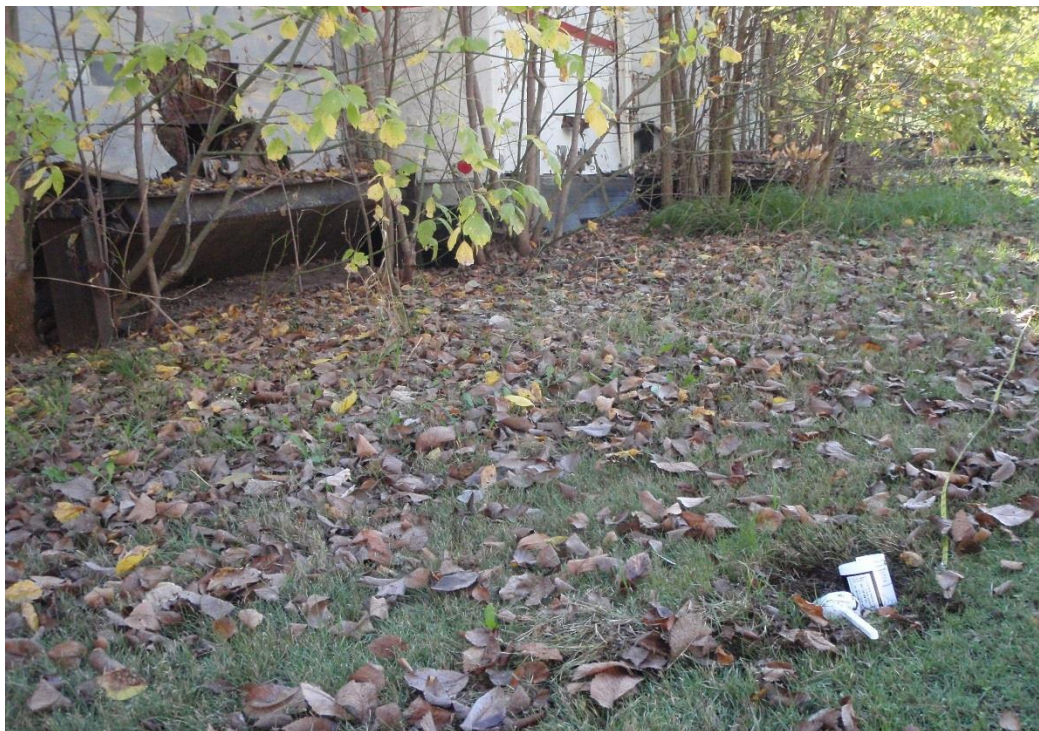
Photograph #9

Comments: Soil Sample

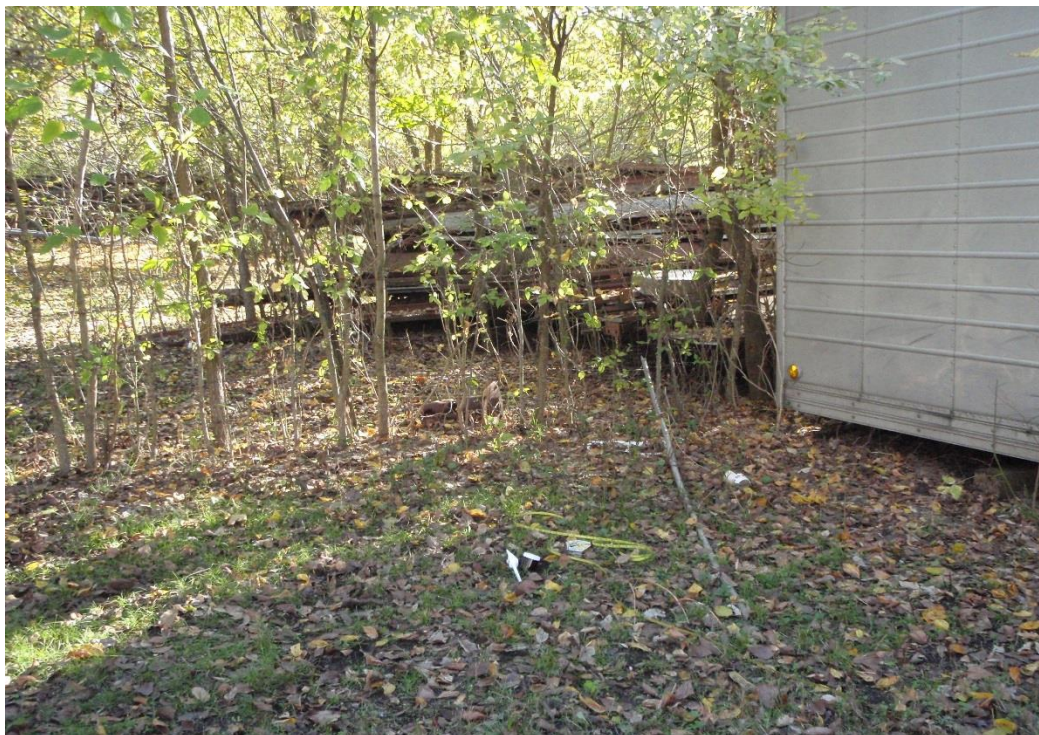
Photograph #10

Comments: Soil Sample

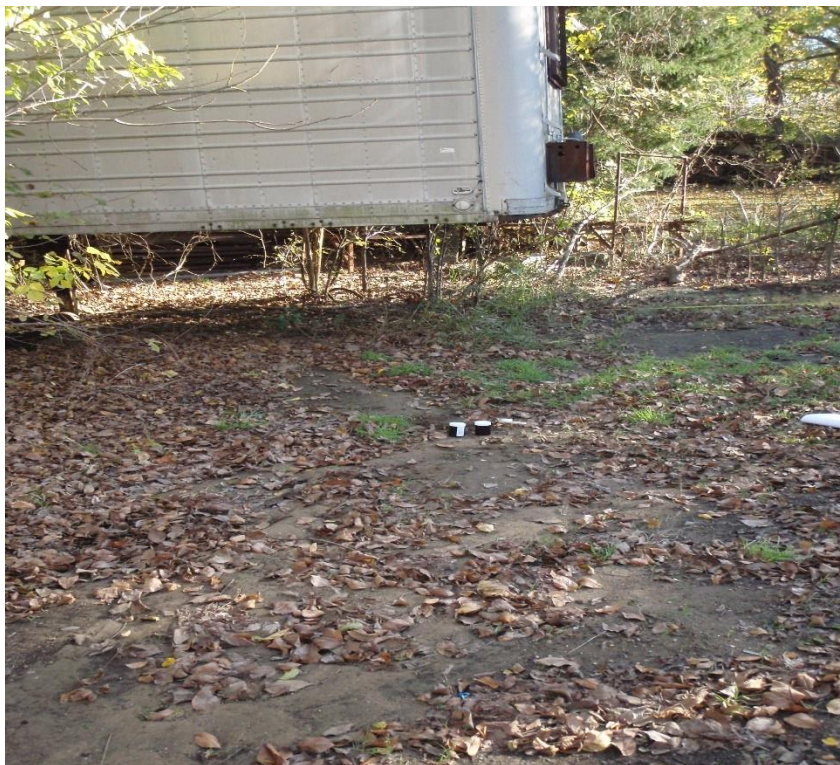
Photograph #11

Comments: Soil Sample

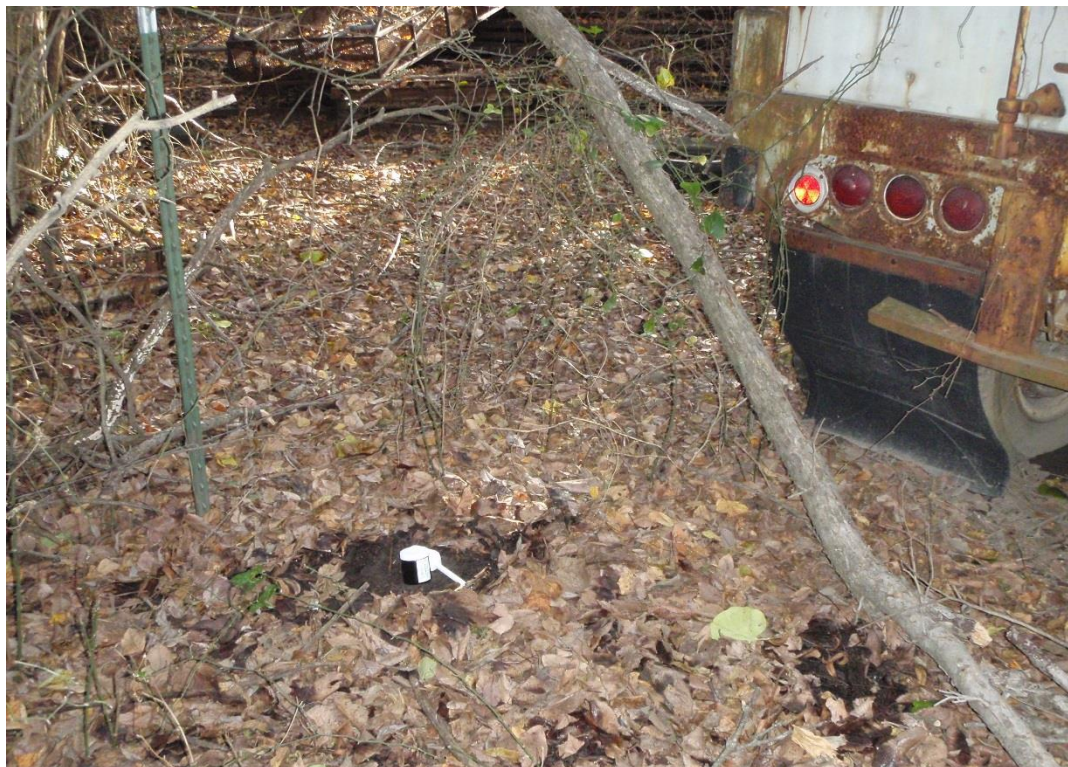
Photograph #12

Comments: Soil Sample

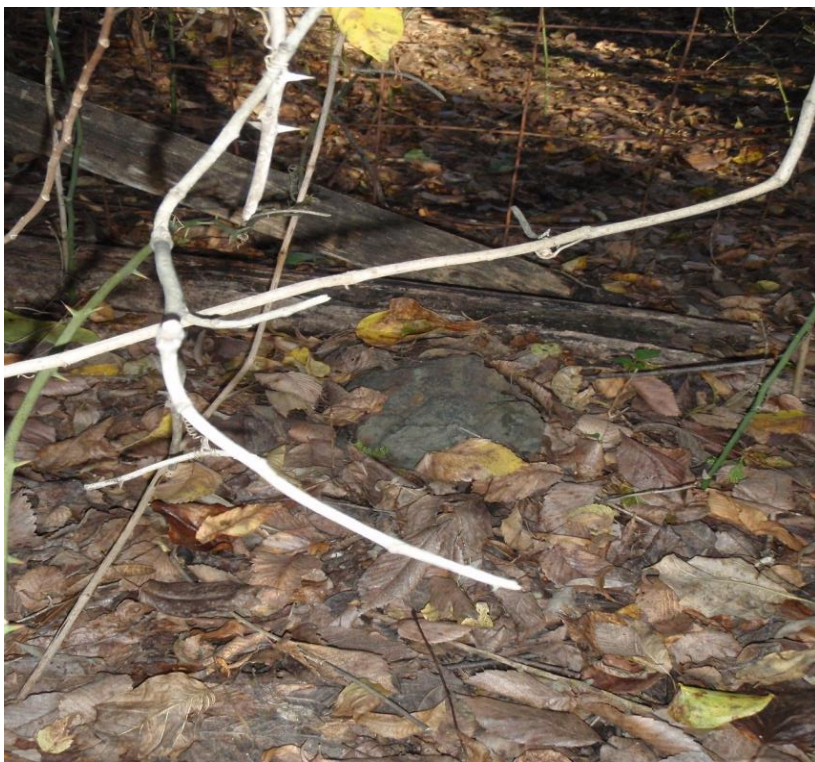
Photograph #13

Comments: A piece of grinding grit located at the southeast corner of the fence.

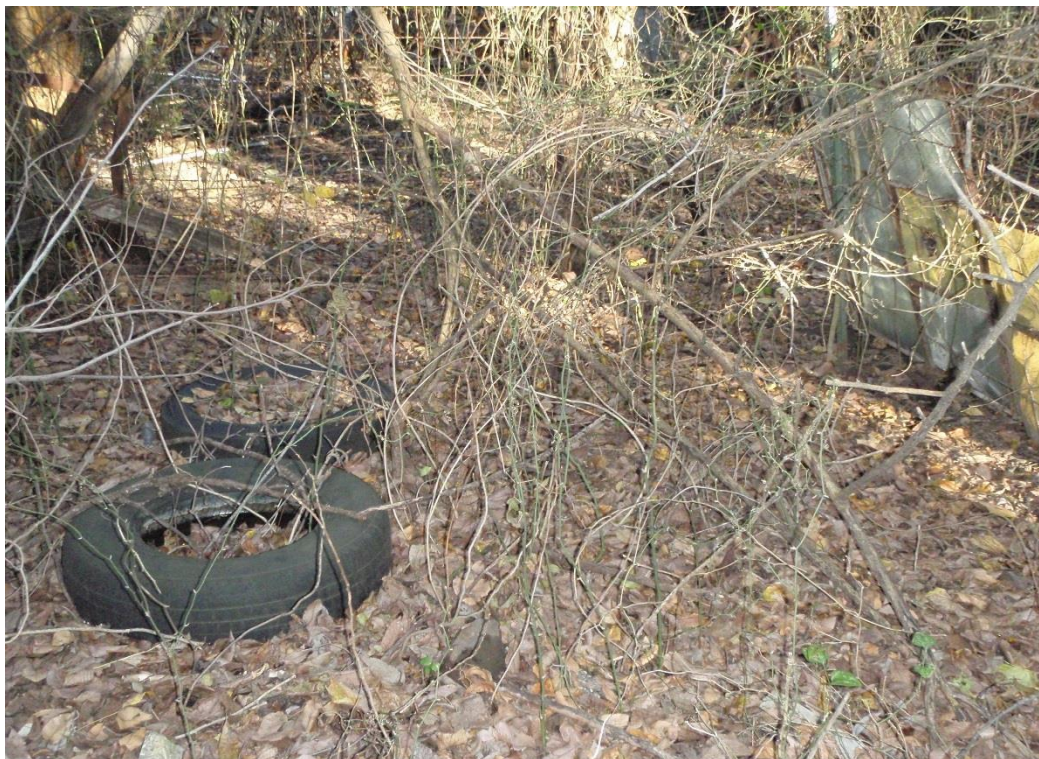
Photograph #14

Comments: Grinding grit fragments observed in this area near the southeast property line within some trees and brush.

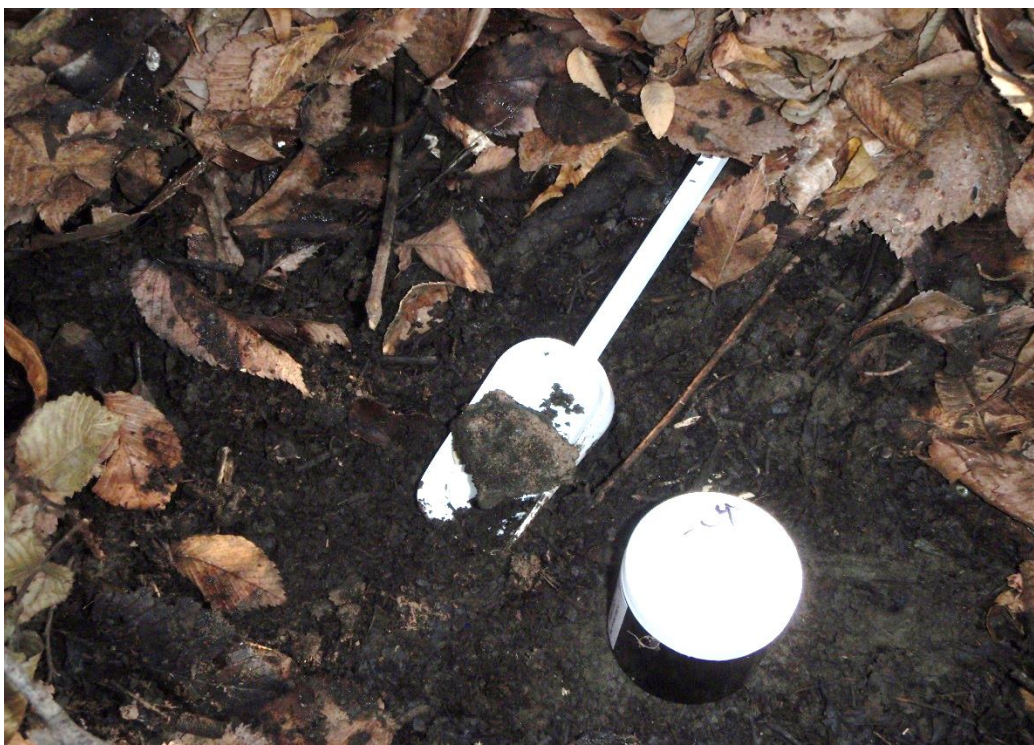
Photograph #15

Comments: A piece of grinding grit observed near the southeast property line near the fence.

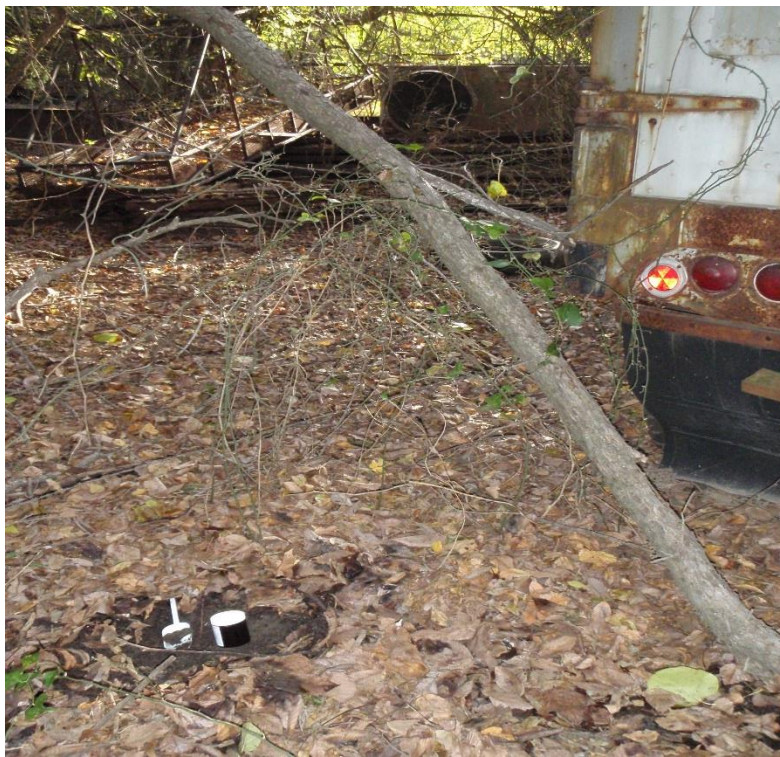
Photograph #16

Comments: Soil Sample

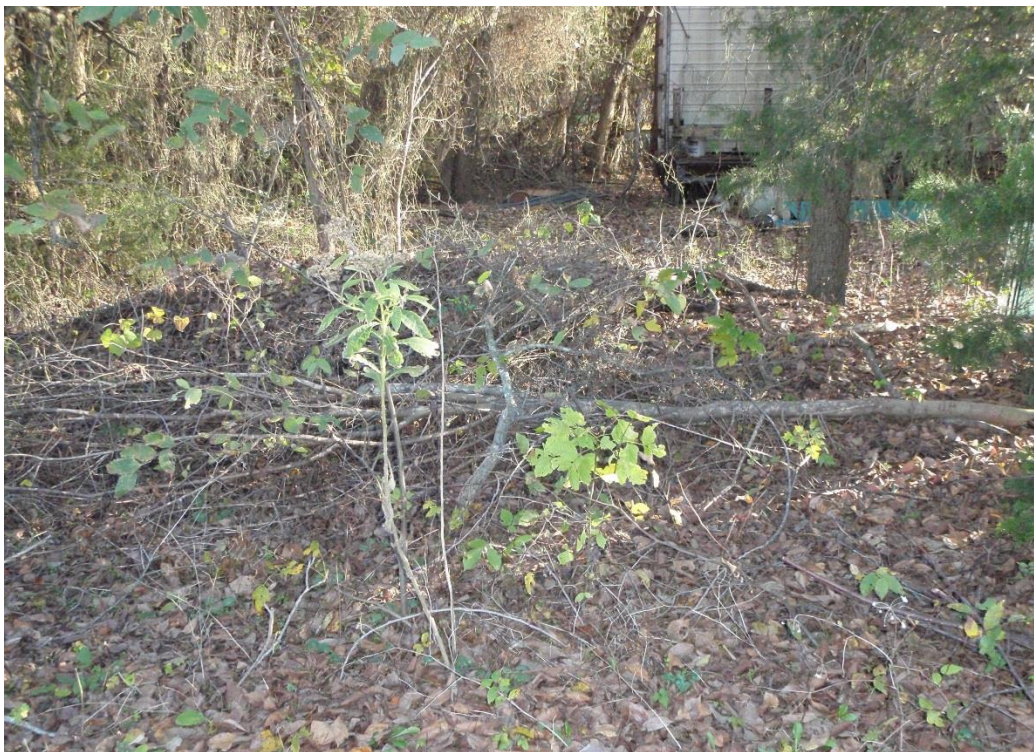
Photograph #17

Comments: Large mound of soil and wood. Grinding grit was observed in this area.

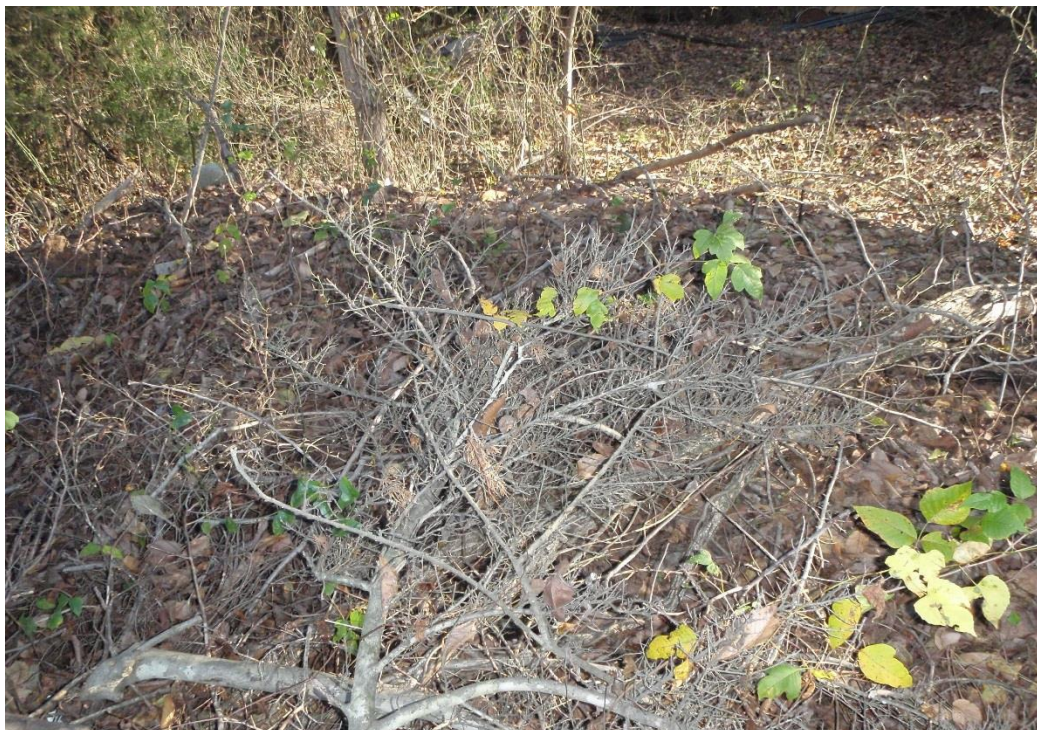
Photograph #18

Comments: Large mound of soil and wood. Grinding grit was observed in this area.

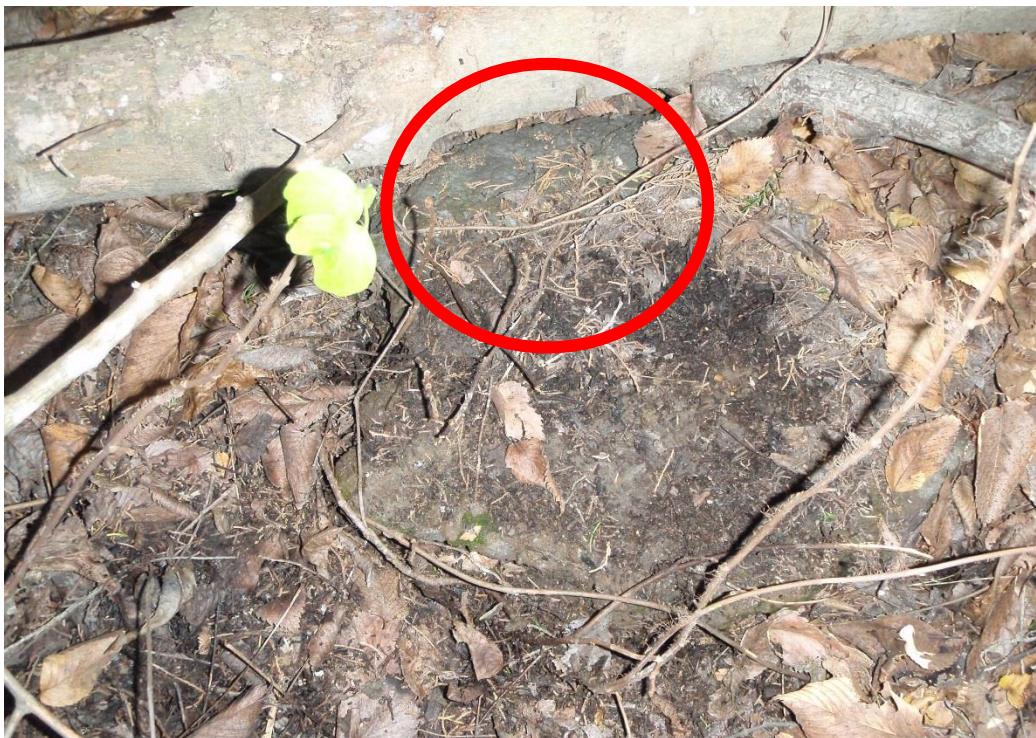
Photograph #19

Comments: Grinding grit.

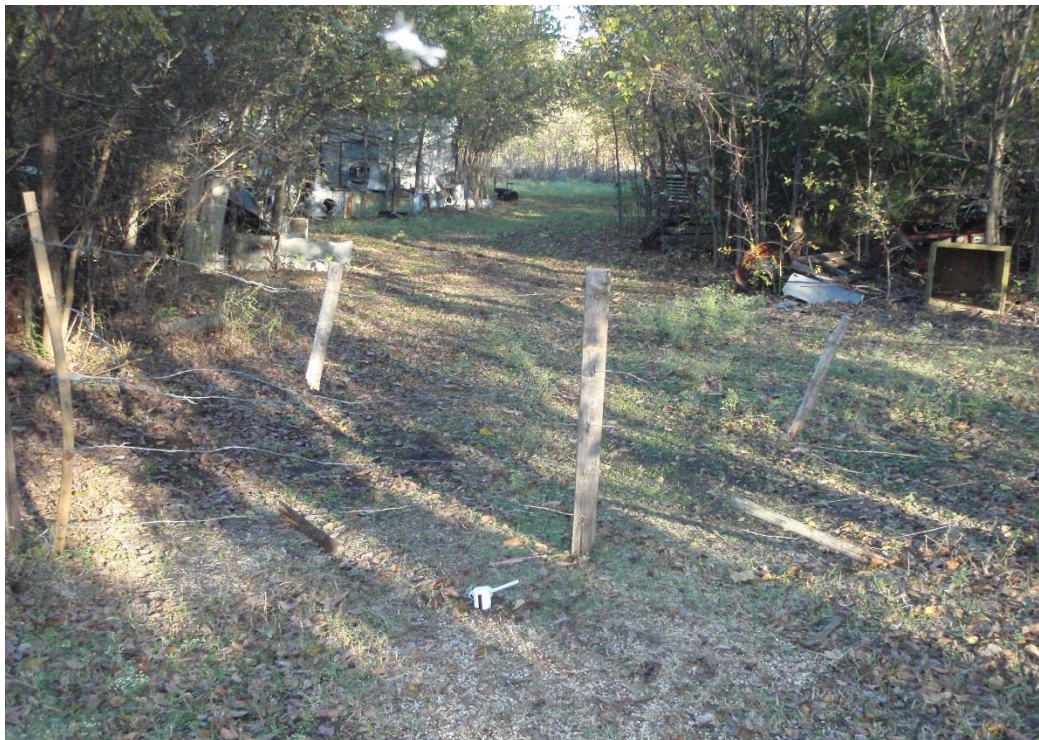
Photograph #20

Comments: Soil Sample

Plating equipment and horses located on the other side of the fence. The adjacent property is also owned by Stag Management, the former operators of Lane Plating.

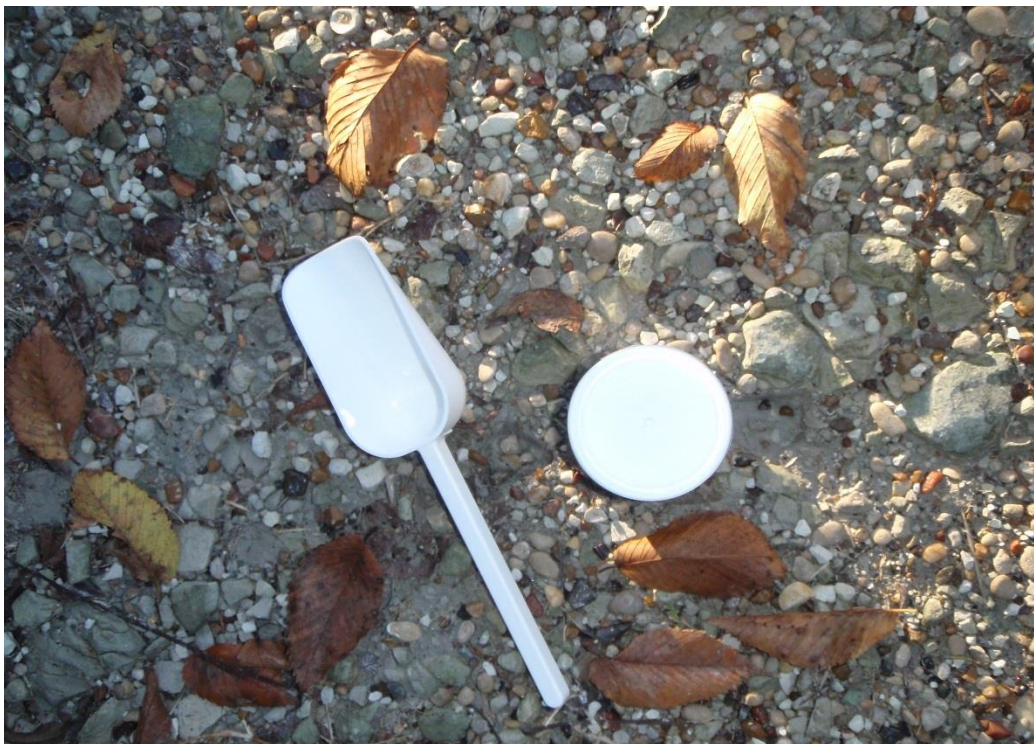
Photograph #21

Comments: Soil sample collected from a discolored area near the treatment building. A greenish substance appears to have been discharged from a tote next to the building.

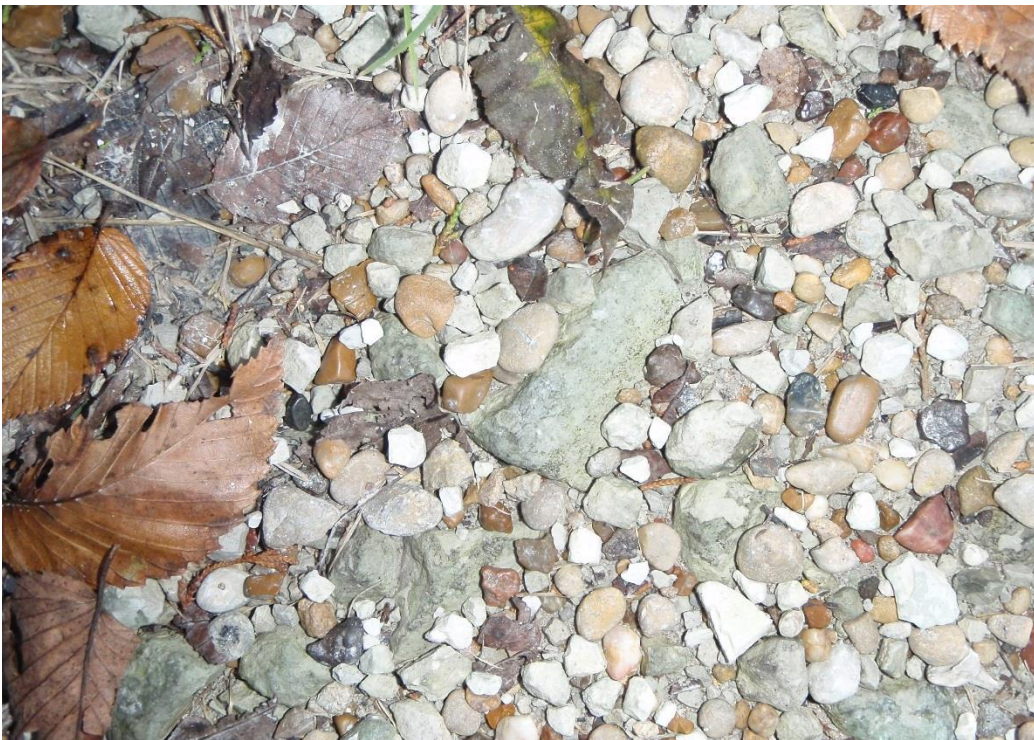
Photograph #22

Comments: Close-up of green discharge that discolored the rocks..
